## IBC's Committee's Recommendations ( Part I )

## A PRIMER

**Central Public Works Department**

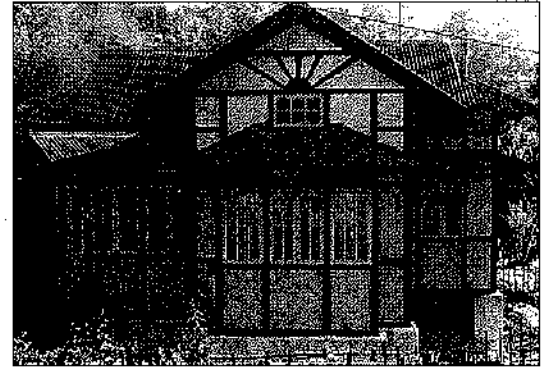
a) Failure of a house with heavy roof  
(after Chamoli earthquake, 1999) (Source: www.nicee.org)

b) "Assam type"-building with light roof

**Figure 7** Examples of low-rise buildings with heavy and light roofs

For single storeyed buildings, there have been several failures due to heavy roof made up of stones, slates, poorly reinforced concrete slabs etc (Figure 7a). On the other hand, lighter buildings are affected less. This was an important lesson learned from the great Assam earthquake of 1897 (magnitude 8.1), which destroyed almost all buildings (up to 3 storeyed). Following this disaster, constructions were limited to single and double storeyed "Assam type" dwellings with light roof (Figure 7b). This was considered the ideal earthquake-resistant construction in North-East India, which falls under the highest seismic zone (Zone V) in the country.

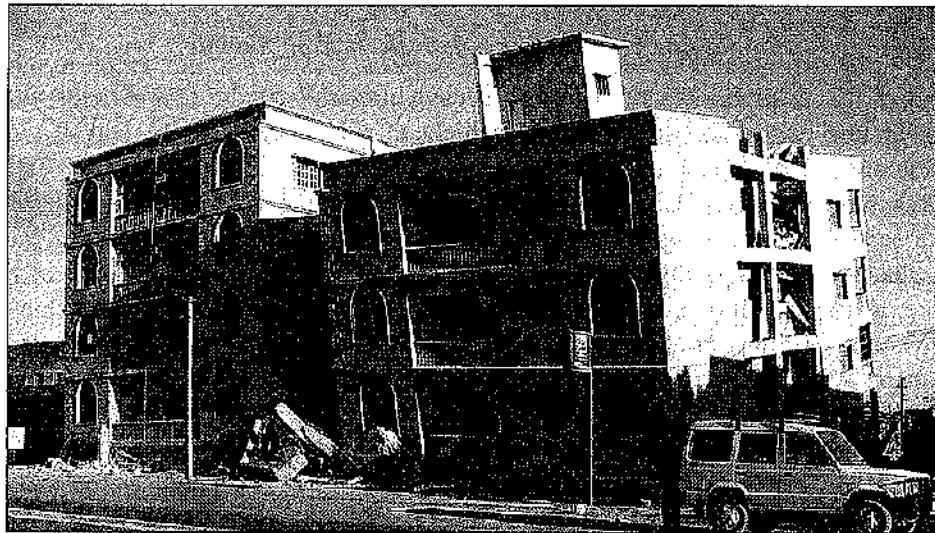
**Figure 10** Collapse of the ground storey of a building  
(after Bhuj earthquake, 2001) (Source: [www.nicee.org](http://www.nicee.org))

building. If the strength is not adequate, the component will fail. The failure of the vertical components in a building (such as load bearing walls, columns or footings) is more critical than that of the horizontal components (such as beams and slabs). This is because the former type of failure is likely to trigger a collapse of the entire building, whereas the failure of a beam may cause only a local damage. In the Gujarat earthquake in 2001, multi-storeyed buildings collapsed because of the failure of the columns in the ground storey (Figure 10).

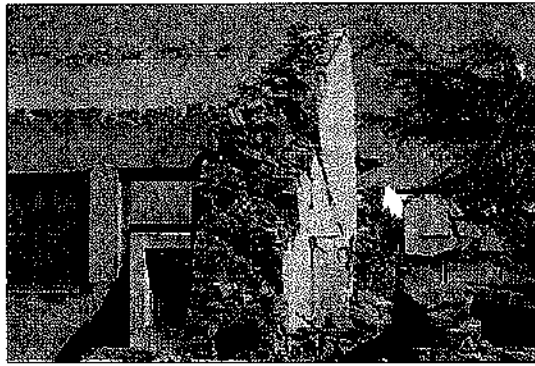
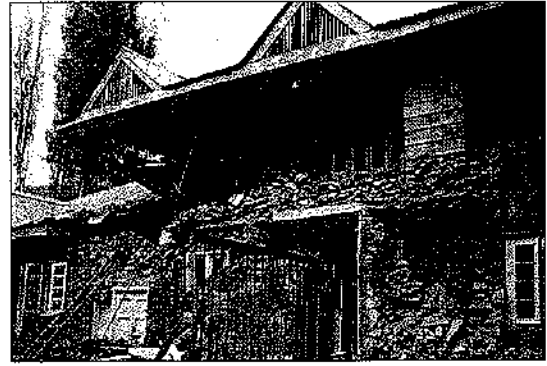
**Figure 13** Collapse of brittle and poorly bonded stone masonry walls

a) After Latur earthquake, 1993  
(Source: www.nicee.org)

b) After Kashmir earthquake, 2005  
(Courtesy: Central Public Works Department)

In a similar way, buildings too can exhibit either ductile or brittle (non-ductile) behaviour, depending on the structural material, design and detailing. Materials like brick, stone and plain concrete are relatively brittle. When bricks or stones are used in masonry wall construction without adequate bond, they can fall apart suddenly, even if the walls are relatively thick. This indeed is how many buildings collapsed during the Latur earthquake and Kashmir earthquake (Figure 13). Many such buildings have weak mud mortar or no mortar at all. On the other hand, masonry buildings with reinforced concrete bands can exhibit better behaviour.

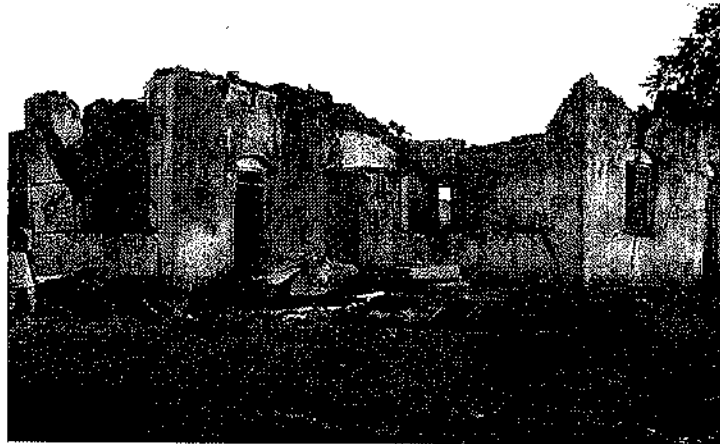
**Figure 15** Poor integrity in a masonry building (after Latur earthquake, 1993) (Source: [www.nicee.org](http://www.nicee.org))

To ensure that the seismic forces are safely transmitted from the floor levels to the foundations, the connections of the various components should be adequate. This requirement is part of ensuring the *integrity* of the building. In a masonry building, the roof and any intermediate floor slab (between the roof and ground floor) should be strongly connected to the walls. Also, the walls should be properly inter-connected. If the connections between the walls or between the slab and the walls are not effective, a building has limited strength to resist seismic forces. The walls can collapse even under a minor earthquake shaking (Figure 14b). Figure 15 illustrates the collapse of walls due to poor integrity.

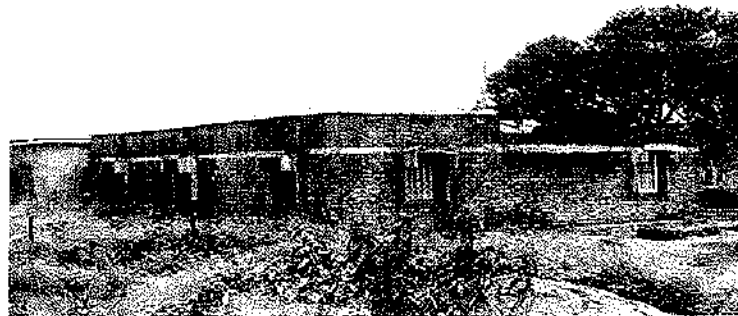
**Figure 16** Good integral action in a masonry building with lintel band (after Latur earthquake, 1993) (Source: [www.nicee.org](http://www.nicee.org))

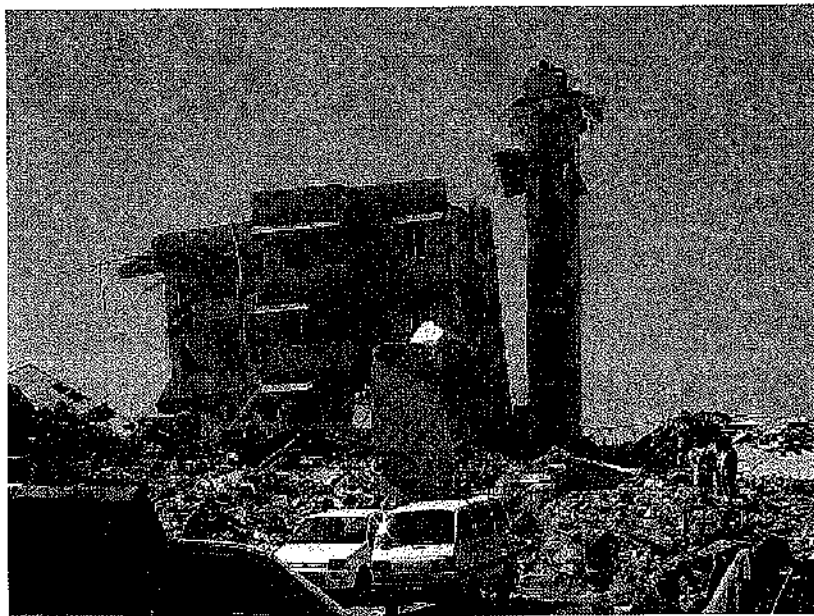
**Figure 17** Lack of integrity between lift core and rest of the building (after Bhuj earthquake, 2001) (Source: [www.nicee.org](http://www.nicee.org))

Reinforced concrete shear walls, commonly provided around lift cores, are usually very strong and stiff. However, unless these shear walls are integrally connected to the rest of the building framework, they will not serve the desired purpose. Figure 17 illustrates such a situation where the lift core alone is found to survive with relatively little damage, but the rest of the building separated out due to lack of integrity and collapsed.

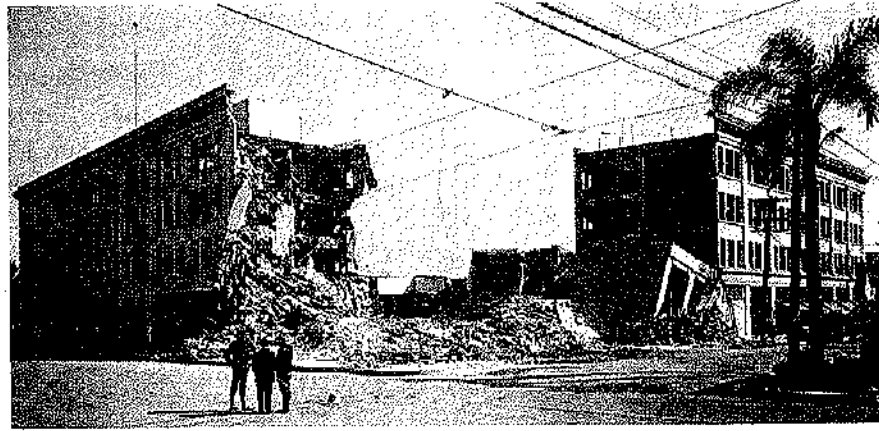
**Figure 19** Collapse of an "L" shaped building (after Skopje earthquake, Macedonia, 1963)

The *plan* implies the view of the building vertically down from a point sufficiently above the building. A building should have a simple geometrical shape in plan, such as rectangular or circular. All rectangular shapes are not uniformly good. If the building is too long in one direction, it is likely to be damaged during an earthquake. A building with large cut-outs (or openings) in the floors and roofs is undesirable, as these affect the integrity of the building. Buildings which are 'H', 'L', 'T', 'U', '+', or similar shapes in plan are also undesirable, because these shapes generate severe stresses at the interior corners of the buildings (Figure 18). Each wing of such a building tends to vibrate separately in the event of an earthquake, causing serious damage that may lead to collapse (Figure 19).

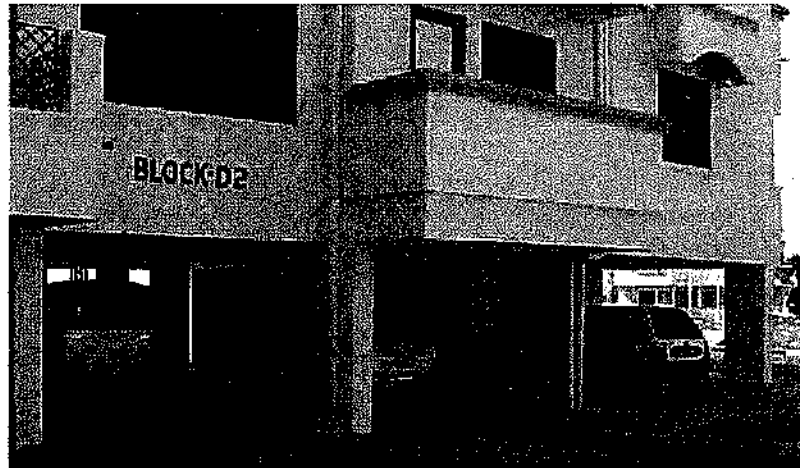
**Figure 22** Building with open ground storey (Source: [www.nicee.org](http://www.nicee.org))

The *elevation* refers to the horizontal view of the building from a point sufficiently away. Buildings should be simple not only in plan but also in elevation. The walls and columns should continue uninterrupted from top to bottom, to ensure transmission of forces to the supporting ground through the shortest and simplest path. If there is any discontinuity in the path of load transmission, there is a high potential of damage in the event of an earthquake. Hence, hanging or floating columns (columns which are supported on beams and do not continue to the foundation) and discontinuity of walls in the ground storey (open ground storey) should be avoided (Figure 21). Walls are not continued in the ground storey for the requirement of parking or shop space. The height of the ground storey is increased for the head room requirement or for the comfort of the first floor tenants. Figure 22 shows an existing residential multi-storeyed building with an open ground storey for car parking.

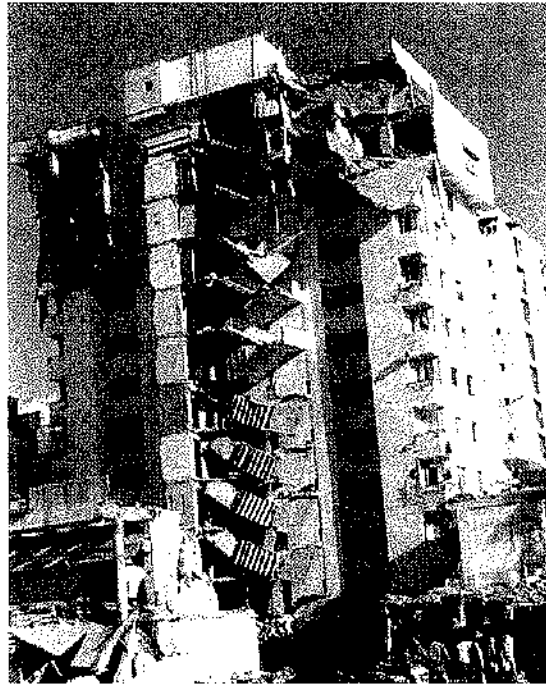
**Figure 27** Collapse of stair slabs  
(after Bhuj earthquake, 2001) (Source: [www.nicee.org](http://www.nicee.org))

Special attention should be given to the planning of the staircases, as these vital escape routes are at times the first ones to attract damage in a major earthquake (Figure 27).

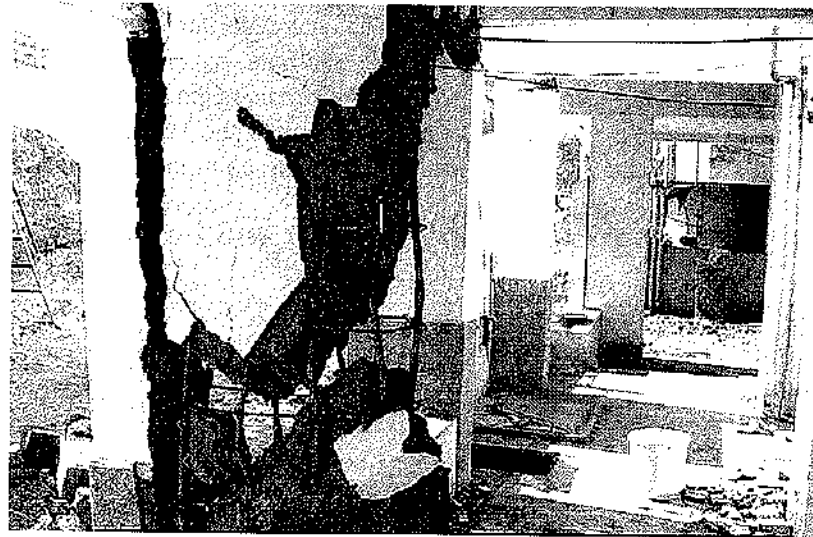
**Figure 39** A shear failure in a column  
(after Bhuj earthquake, 2001) (Source: [www.nicee.org](http://www.nicee.org))

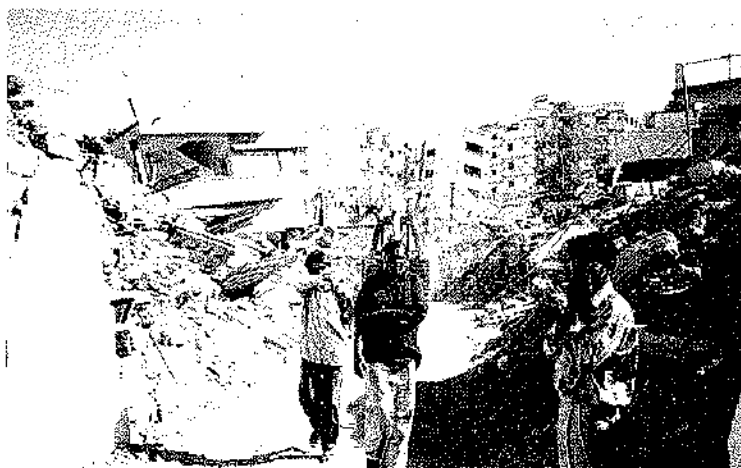
**Figure 45** Ruins of the Bhuj District Hospital  
(after Bhuj earthquake, 2001) (Source: www.nicee.org)

The purpose of seismic retrofitting a building is to enhance the structural capacities (lateral strength, lateral stiffness, ductility, stability and integrity), so that the building can withstand the design level of earthquake. A decision on whether or not to retrofit an unsafe building depends on many factors. Lifeline buildings<sup>1</sup> must necessarily be retrofitted, in view of their extreme importance. Otherwise, they may meet the tragic fate of the Bhuj District Hospital complex (Figure 45). Important buildings should also be retrofitted.
